# **Mold Investigation**

**Governor Winthrop Nursing Center  
142 Pleasant Street  
Winthrop, Massachusetts**

Prepared by:  
Massachusetts Department of Public Health  
Center for Environmental Health  
Emergency Response/Indoor Air Quality Program  
January 2007

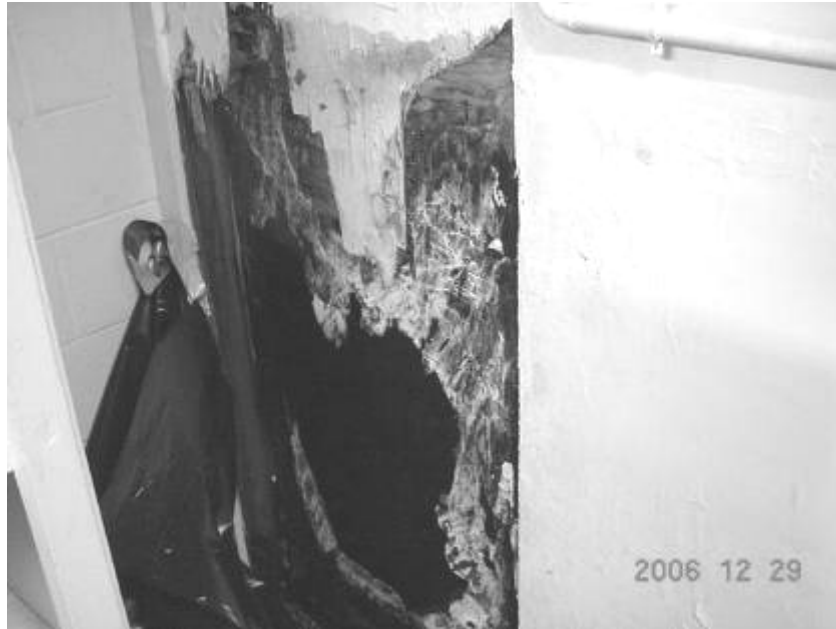
**Picture 1**

Exposure to mold and related particulates can result in irritant symptoms, particularly in sensitive individuals (i.e. those with pre-existing conditions such as allergies, asthma and respiratory disease). At the time of the CEH assessment, severe water damage to wooden walls and visible mold growth was observed in the central supply room (Picture 1). Visible mold growth was also observed on water-damaged gypsum wallboard (GW) in shower room # 3 (Picture 2):

**Visible Mold Growth on Water-damaged Wood and Vinyl Vapor Barrier in Central Supply Room**

1. Continue with plans to complete mold remediation. Remediation activities should be conducted in a manner consistent with recommendations in “Mold Remediation in Schools and Commercial Buildings” published by the US Environmental Protection Agency (US

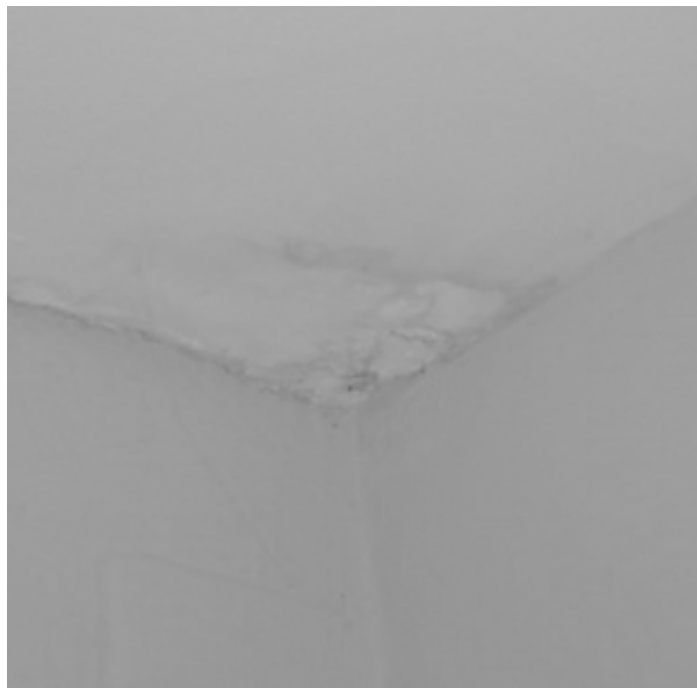
**Picture 2**

**Visible Mold Growth on Water-damaged Gypsum Wallboard Ceiling in Shower Room # 3**

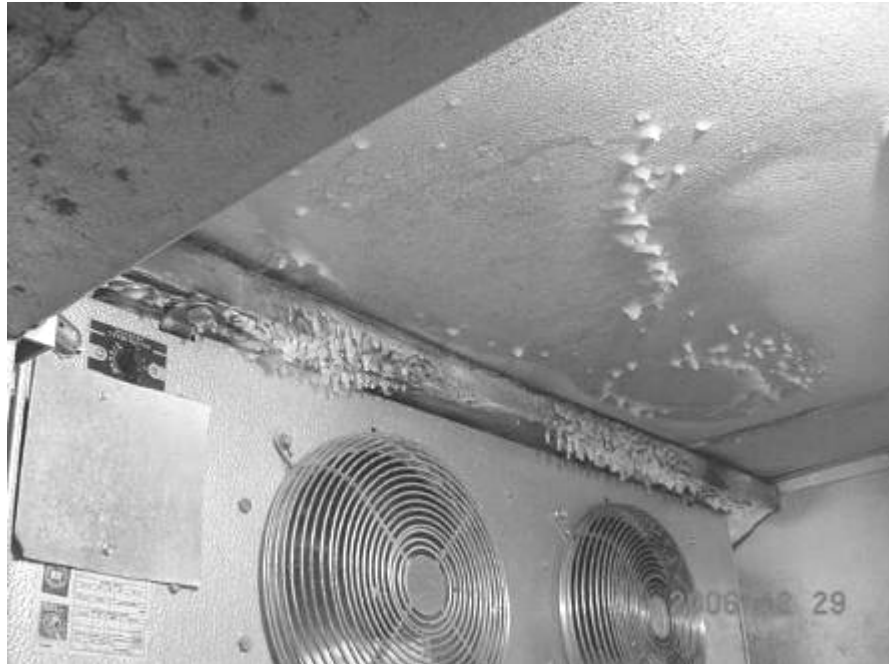
**Picture 3**

central supply room is condensation stemming from the large, walk-in refrigerator in the kitchen that is located adjacent to the central supply room. CEH staff examined the refrigerator and found that the casing had a number of breaches, resulting in ice dams (Picture 3). Several areas inside the refrigerator were damaged and/or corroded (Pictures 4 and 5). The front wall of the refrigerator was severely corroded. Light from within the refrigerator could be observed and cold drafts were escaping into the kitchen (Picture 6). Unless the refrigerator is replaced, new materials that may be housed in the central supply room are likely to be damaged again.

**Ice Build-Up inside Refrigerator**

1. Replace refrigerator to prevent a reoccurrence of water damage to materials surrounding the unit.

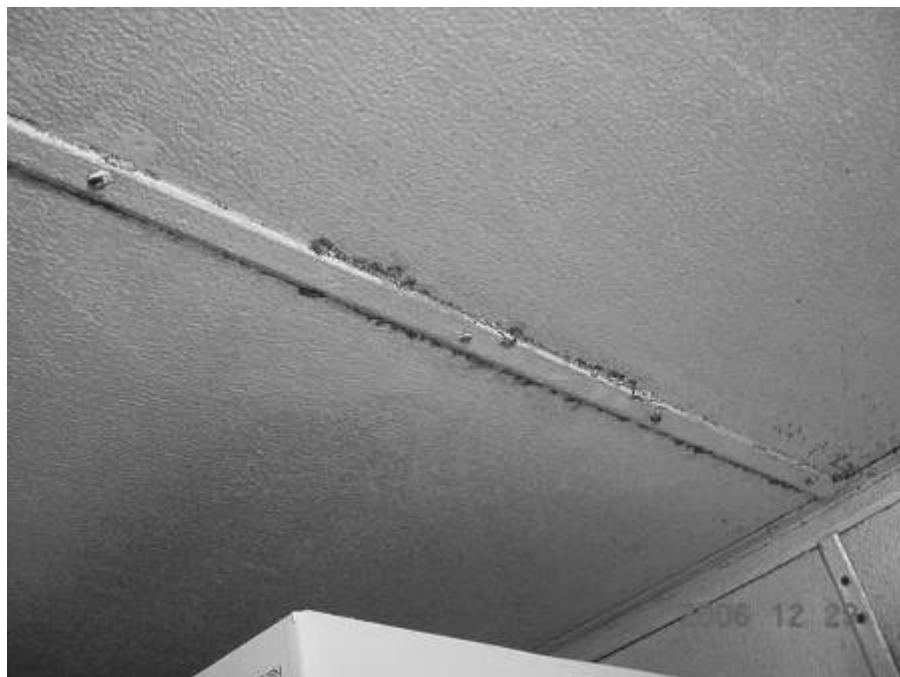
**Picture 4**

**Corrosion along Top Seam of Refrigerator**

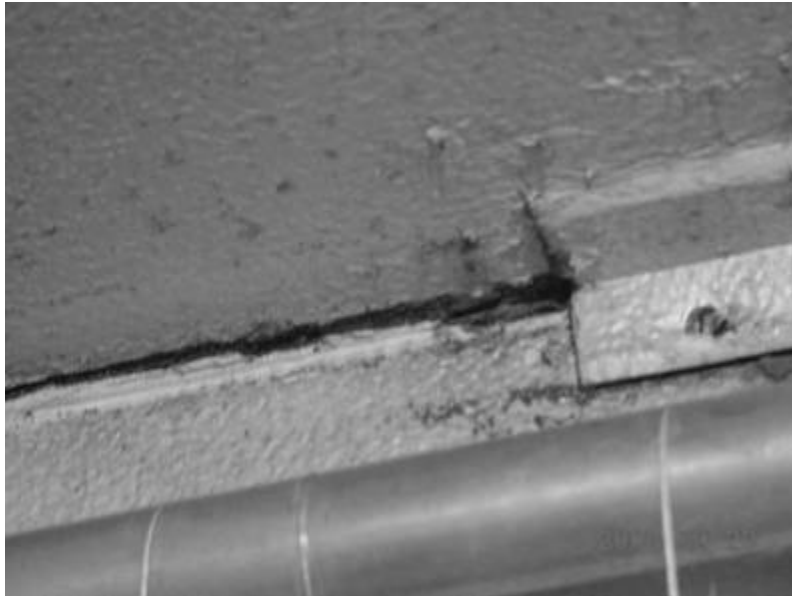
**Picture 5**

**Corrosion of Metal Refrigerator Casing**

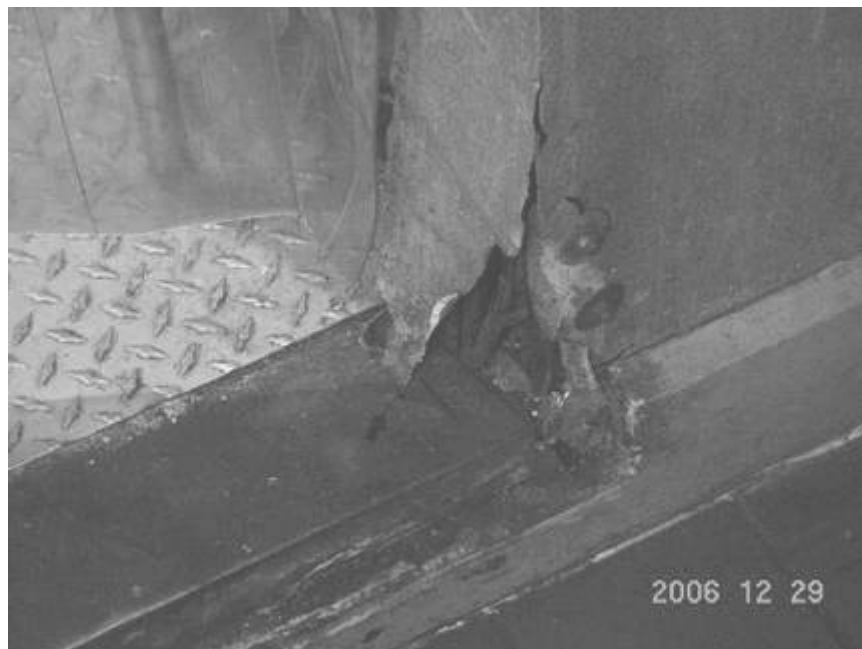
**Picture 6**

**Severe Corrosion of Metal Refrigerator Casing where Light Could be Seen Penetrating and Cold Drafts were Detected**
